MISSION HOME INSPECTIONS

ROOM-BY-ROOM RESIDENTIAL TEMPLATE

1234 Main Street

03/27/2023 9:00AM

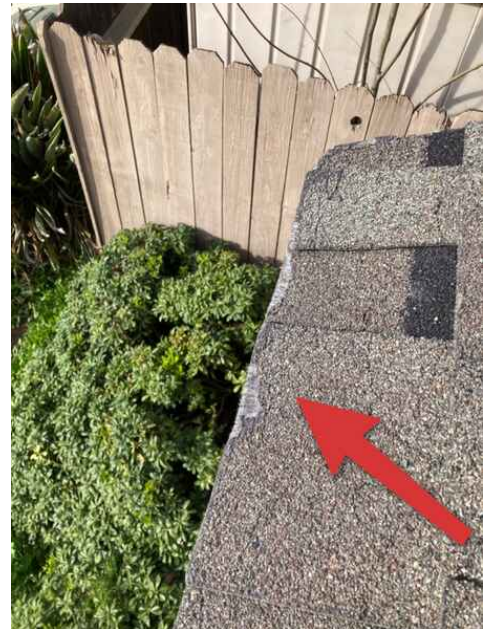
Repair Needed**DAMAGED (GENERAL)**

Roof coverings showed moderate damage and signs of delaminating. The roof seems to be near the end of its lifespan. Recommend a qualified roofing professional evaluate and repair.

Contact a qualified roofing professional.

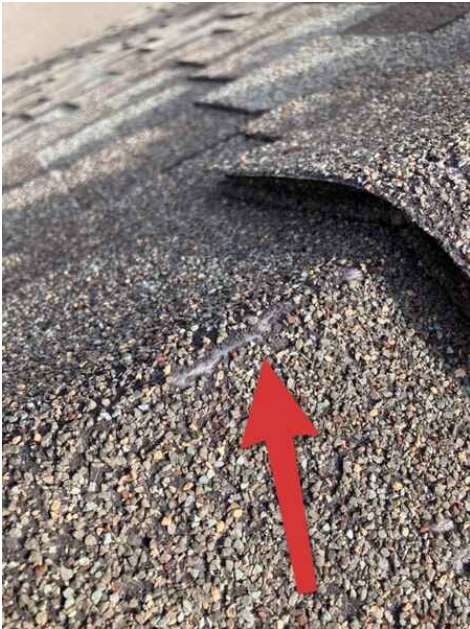
2.1.2 Coverings

Repair Needed**DELAMINATION**

The asphalt shingle roof shows signs of delamination. Delamination is separation of the surface layer of asphalt. Recommend a qualified roofing contractor evaluate and repair to prevent further deterioration that results in leaking and moisture intrusion.

Contact a qualified roofing professional.

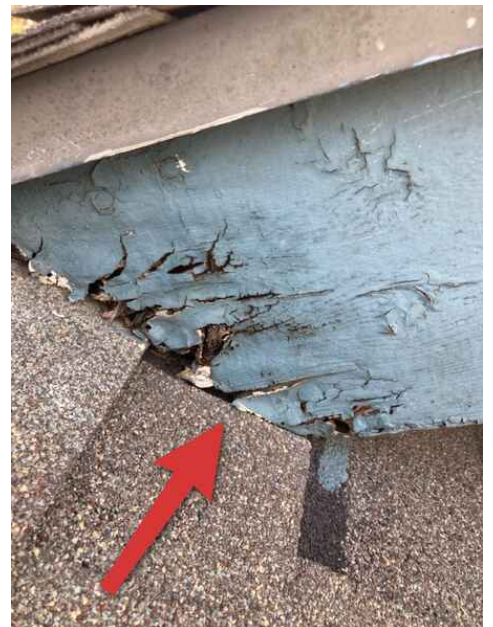
Roof rafter is showing signs of deterioration and rot. I recommend a licensed carpenter evaluate.

Contact a qualified pest control specialist.

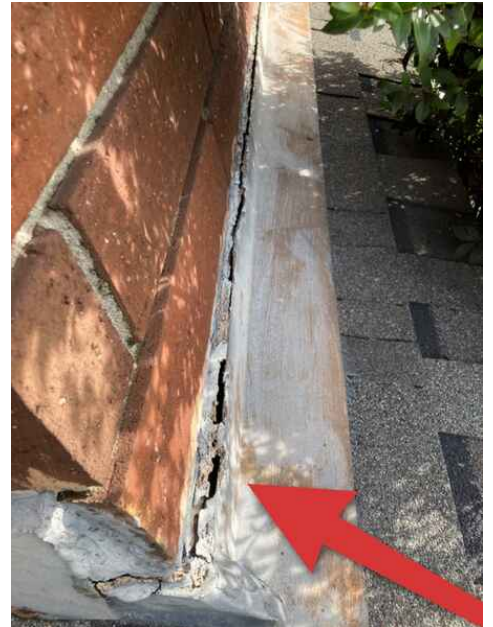
2.2.1 Flashings

LOOSE/SEPARATED

Flashings observed to be loose or separated, which can lead to water intrusion and/or mold. Recommend a qualified roofing contractor repair.

Flashing separating from chimney

Contact a qualified roofing professional.

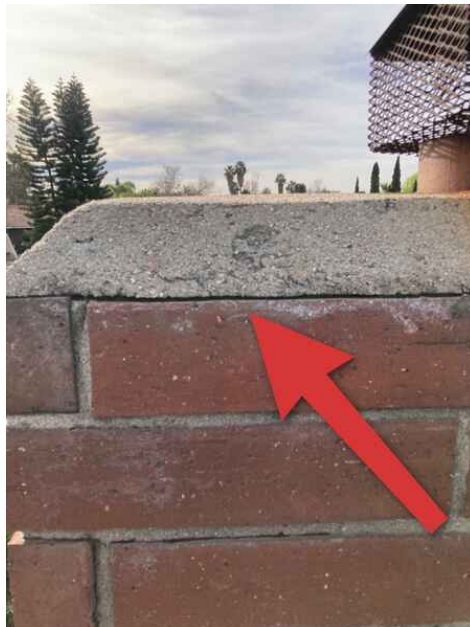
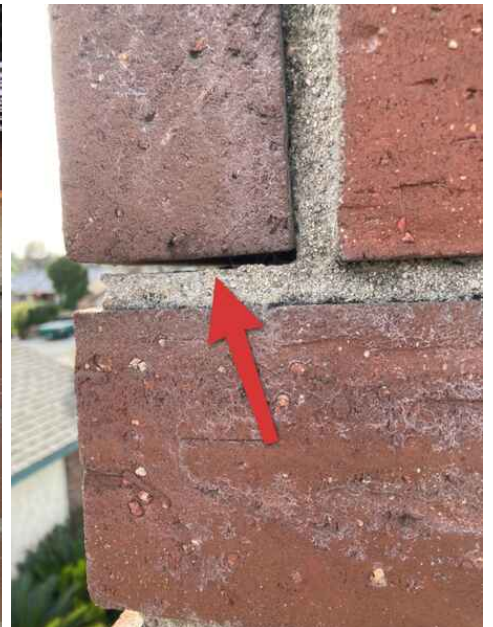
2.3.1 Skylights, Chimneys & Other Roof Penetrations

Joints in the masonry have deteriorated and should be repointed. Repointing is the restoration of the mortar joints in the masonry.

Mortar deterioration

Open space within bricks

Contact a qualified chimney contractor.

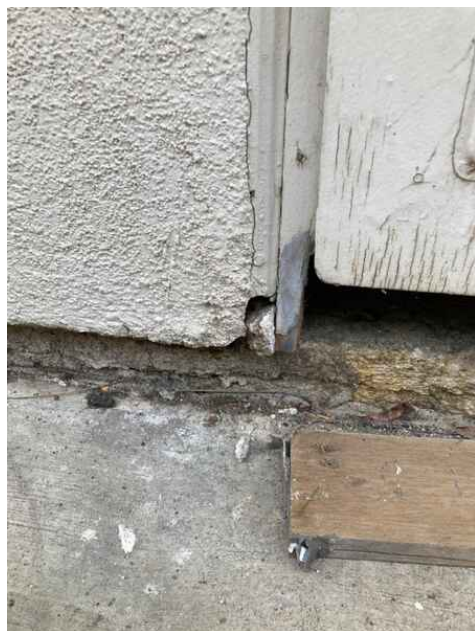
Water heater door

Recommendation

Contact a qualified handyman.

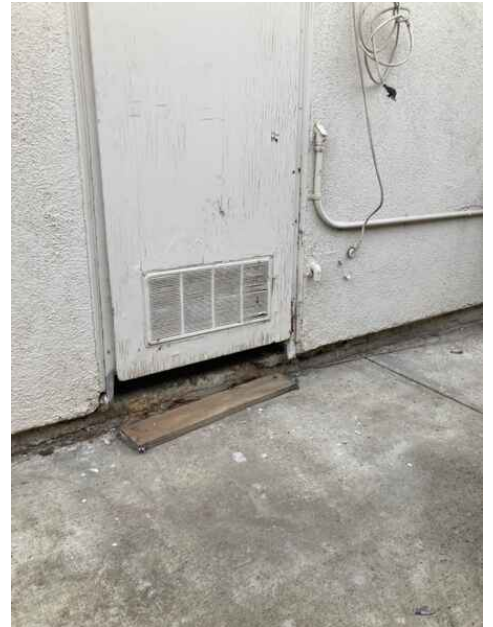
3.2.2 Siding, Flashing & Trim

LOOSE BOARDS

One or more siding boards were loose, which could result in moisture intrusion. Recommend a qualified siding contractor secure and fasten.

Loose Board

Contact a qualified professional.

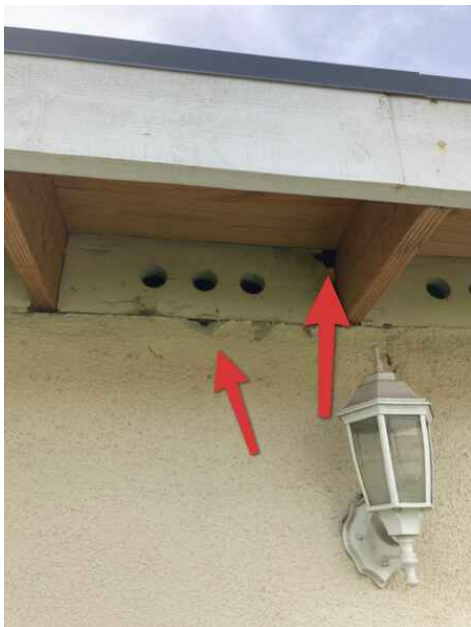
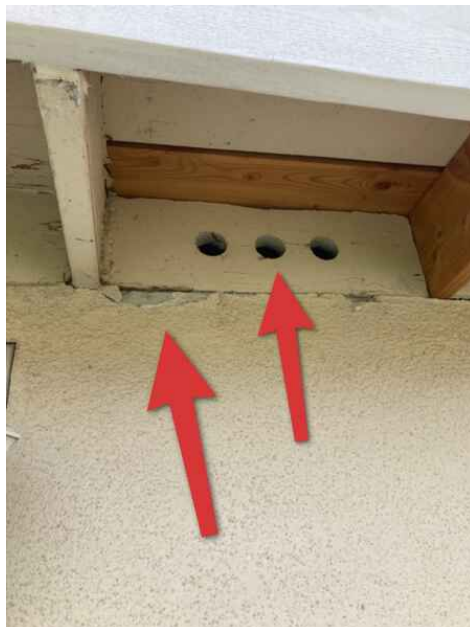
3.2.3 Siding, Flashing & Trim

Multiple areas of the stucco have been chipped away resulting in small openings into the attic. Small openings can lead to moisture intrusion and can allow rodents and insects to enter. I recommend contacting a licensed professional to patch areas.

Contact a qualified professional.

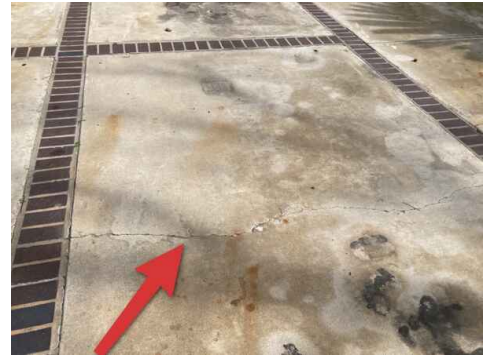
3.4.1 Walkways, Patios & Driveways

DRIVEWAY CRACKING - MINOR

Minor cosmetic cracks observed, which may indicate movement in the soil. Recommend monitor and/or have concrete contractor patch/seal.

Contact a qualified concrete contractor.

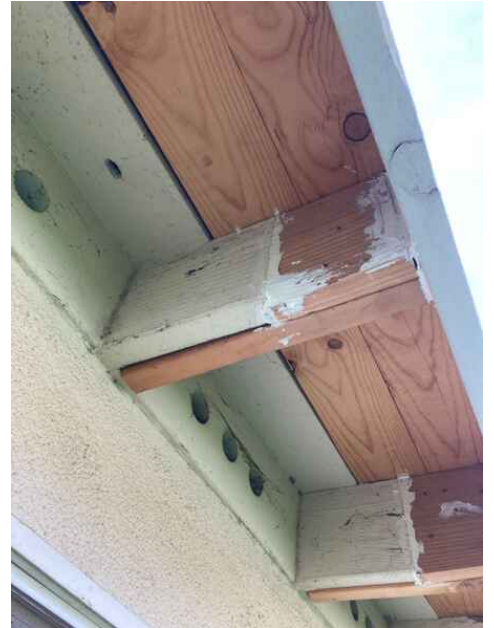
3.6.1 Eaves, Soffits & Fascia

EAVES - DAMAGED

One or more sections of the eaves are damaged. Recommend qualified roofer evaluate & repair.

Contact a qualified roofing professional.

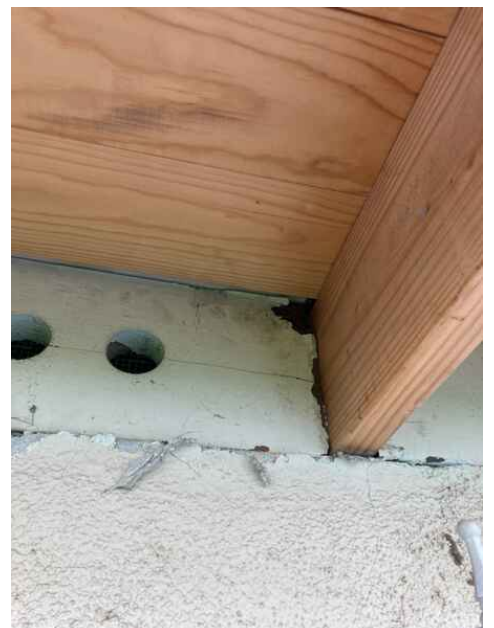
3.6.2 Eaves, Soffits & Fascia

One or more sections of the fascia are rotted. Recommend qualified roofer evaluate & repair.

Contact a qualified roofing professional.

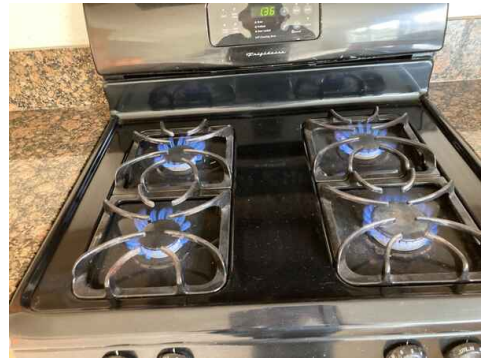
5.3.2 Range/Oven/Cooktop

STOVE VENTILATION

Ventilation hole not properly sealed. Recommend sealing to prevent energy loss.

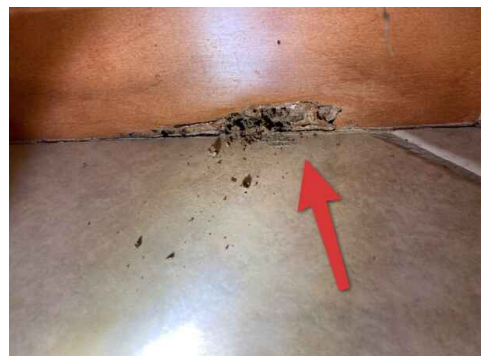
5.3.3 Range/Oven/Cooktop

KITCHEN BASEBOARD

Baseboard and kitchen shows signs of termites. Recommend a licensed pest control contractor evaluate.

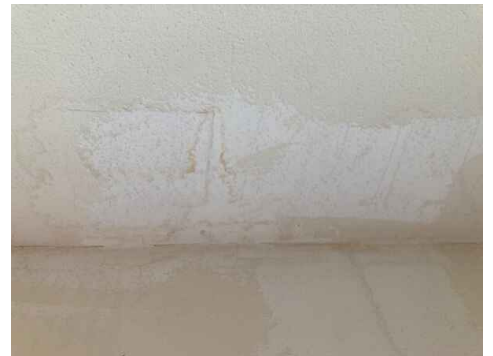
5.5.1 Kitchen ceiling

Ceiling above a slider door shows signs of previous water damage.

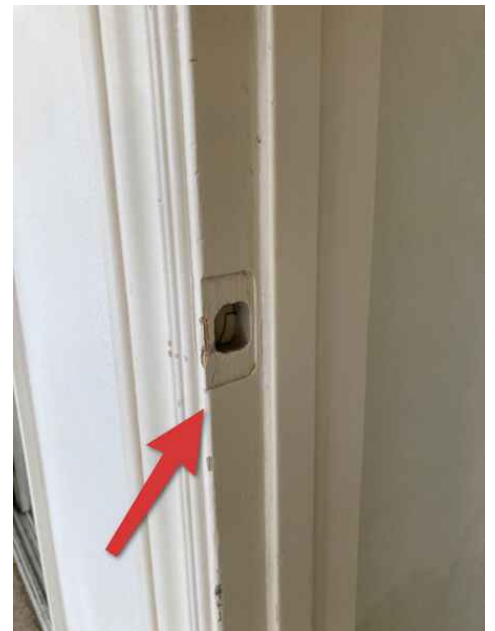
Repair Needed**STRIKE PLATE MISSING**

Recommended to Install strike plate to protect door frame to help protect frame.

Strike plate missing

Recommended DIY Project

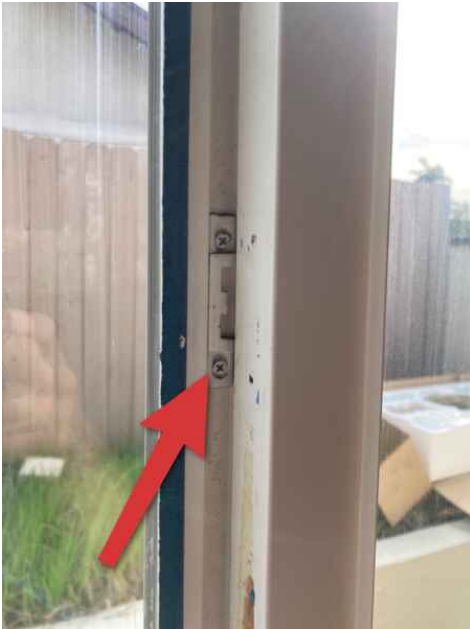
7.3.1 Windows

Repair Needed**DAMAGED**

One or more windows appears to have general damage, but are operational. Recommend a window professional clean, lubricate & adjust as necessary. Window is also missing lock mechanism.

Window missing lock mechanism

Contact a qualified window repair/installation contractor.

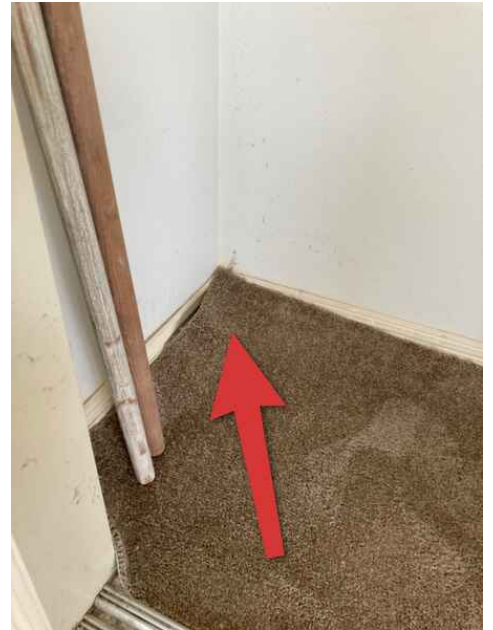
7.4.1 Floors

LOOSE CARPET

Carpet located in closet is not secured to the floor. I recommend a licensed carpet professional re-secure carpet.

Carpet not secure

Contact a qualified flooring contractor

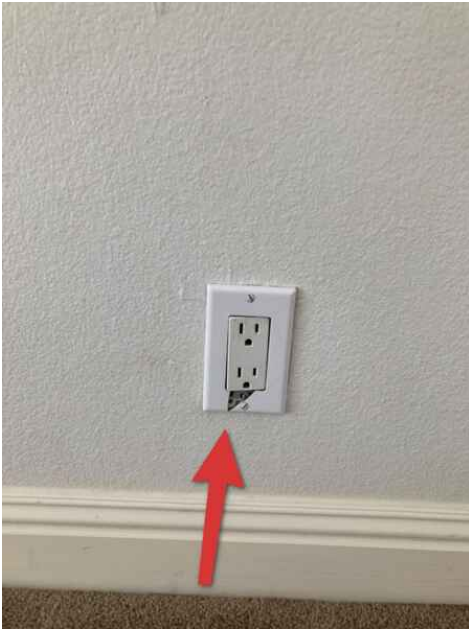
7.7.1 Lighting Fixtures, Switches & Receptacles

COVER PLATES DAMAGED

One or more receptacles have a damaged cover plate. Recommend replacement.

Broken cover plate

Contact a qualified electrical contractor.

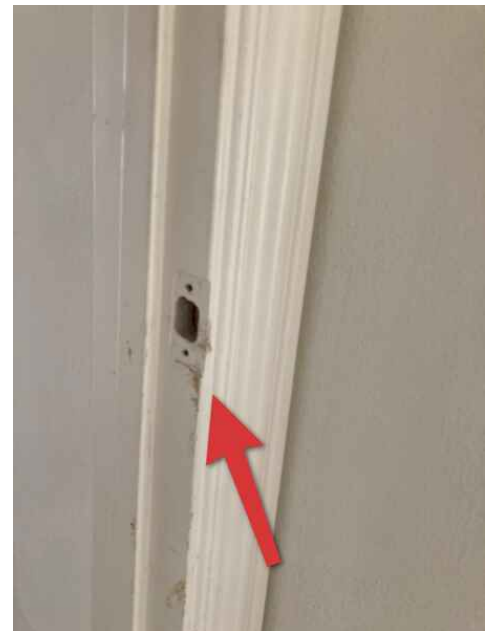
Repair Needed**DOOR DOESN'T LATCH**

Door doesn't latch properly. Recommend handyman repair latch and/or strike plate.

No strike plate

Contact a qualified handyman.

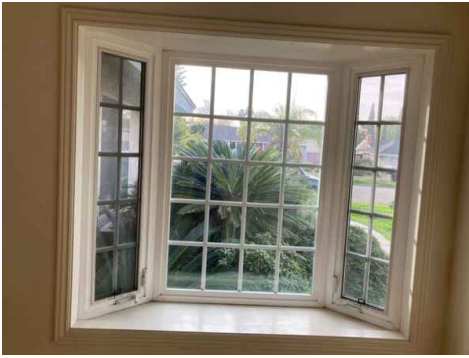
Repair Needed**WINDOWS**

Windows are difficult to open. Recommend window professional lube, and perform maintenance on windows.

Contact a qualified professional.

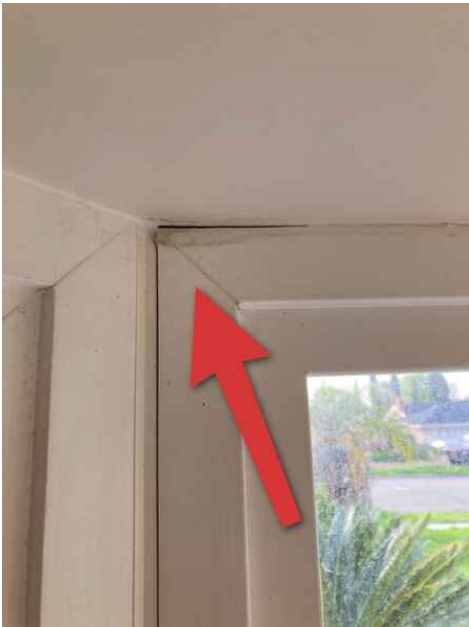
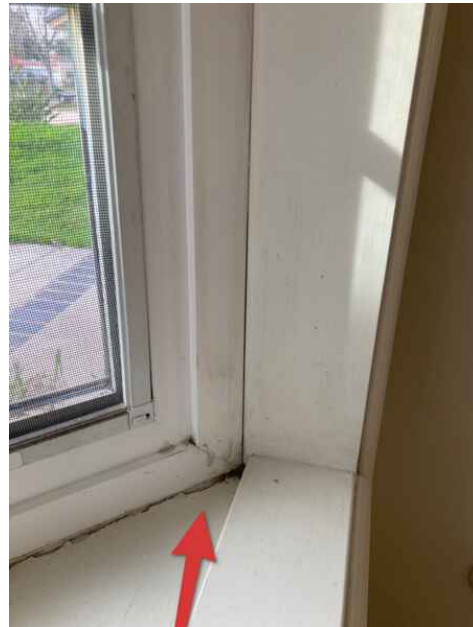
8.3.2 Windows

Recommend re-caulking all window seals to seal gaps. This helps to prevent moisture intrusion.

Re-caulk gap

Contact a qualified handyman.

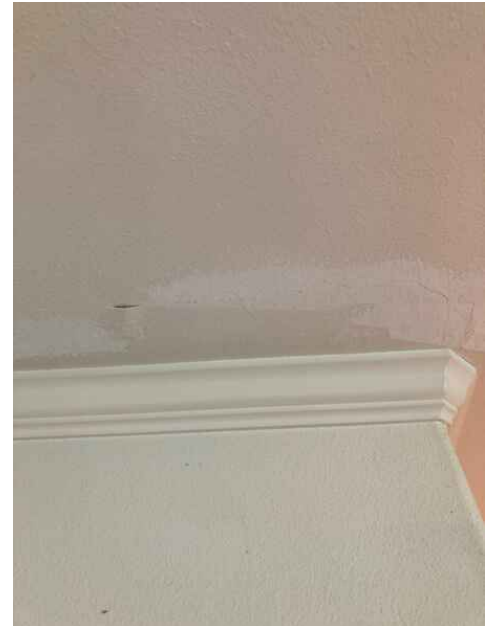
Repair Needed**POOR PATCHING**

Sub-standard drywall patching observed at time of inspection. Recommend re-patching.

Contact a qualified drywall contractor.

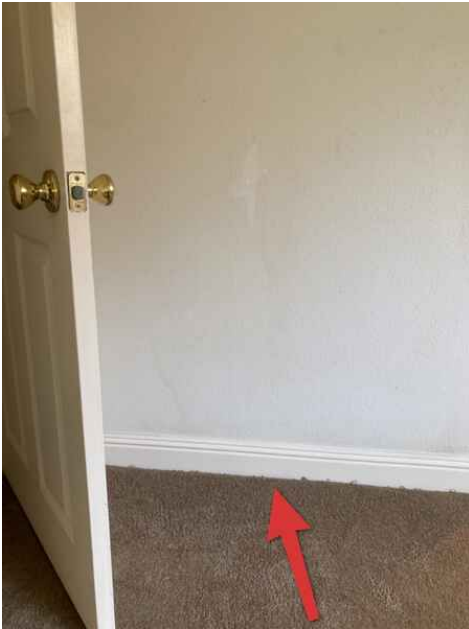
9.5.2 Walls

Repair Needed**DOORSTOP**

No doorstop present. Recommend installing doorstop to prevent holes in wall.

No door stop

Recommended DIY Project

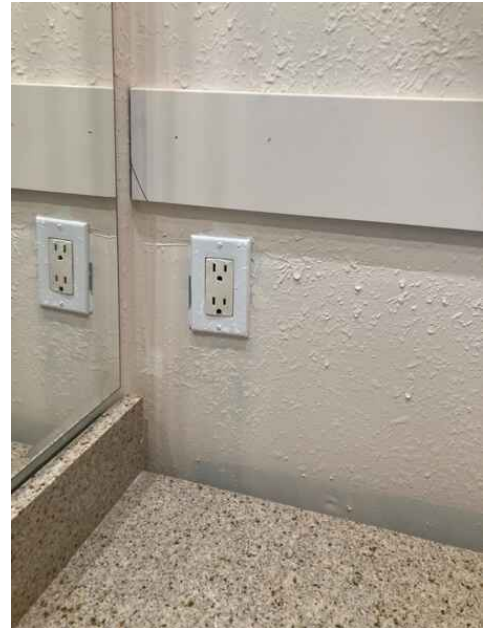
9.8.1 GFCI & AFCI

No GFCI protection present in bathroom. Recommend licensed electrician upgrade by installing ground fault receptacles in all locations.

No GFCI

Contact a qualified electrical contractor.

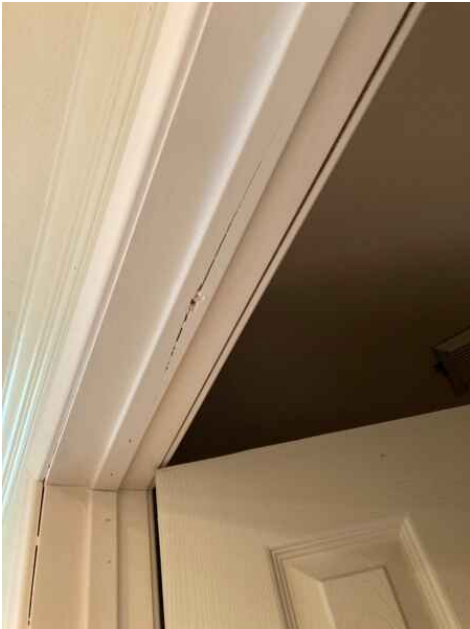
9.11.1 Master bathroom

Door frame in master bathroom, cracked and broken.

Contact a qualified carpenter.

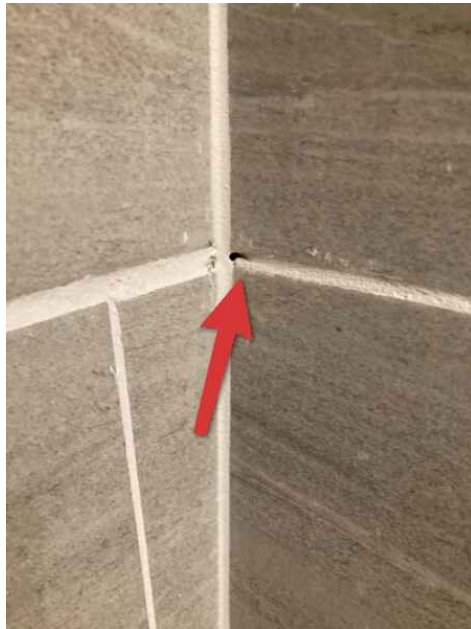
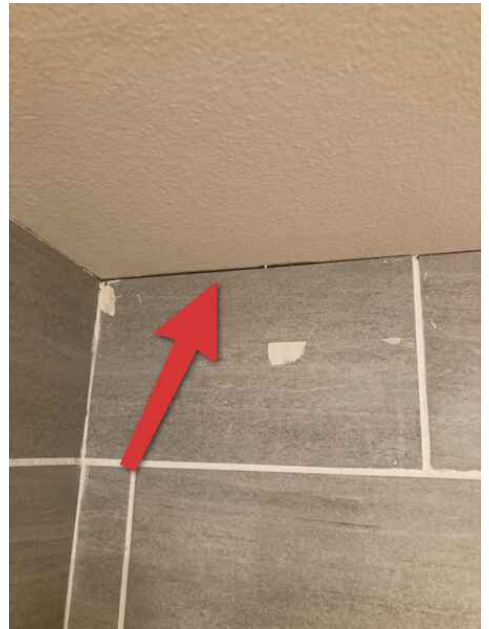
9.12.1 Master bathroom

Shower in master bedroom has multiple areas of grout missing between tiles. Sealing holes will help prevent moisture intrusion, and moisture damage

Contact a qualified professional.

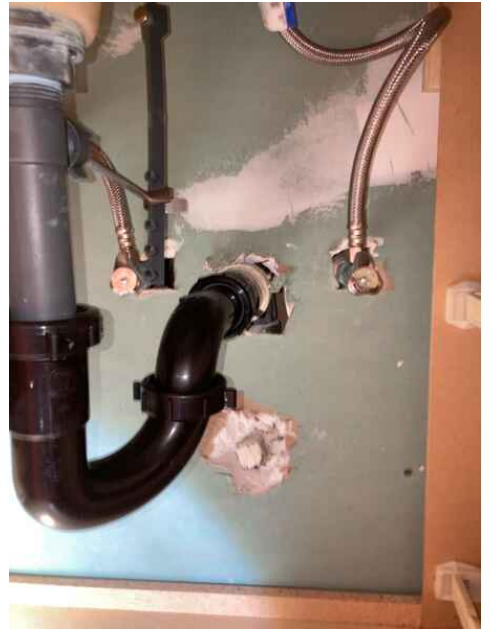
9.12.2 Master bathroom

Wall under the sink has unsealed holes around the drain and water lines. This could result in home energy loss recommend sealing

Contact a qualified professional.

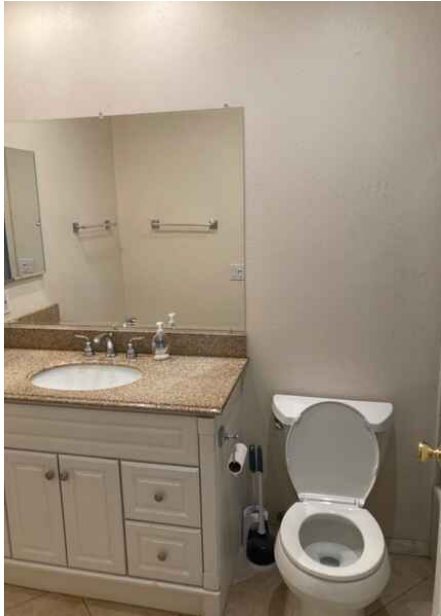
Water Supply, Distribution Systems & Fixtures: Distribution Material
Copper

Water Supply, Distribution Systems & Fixtures: Water Supply Material
Copper

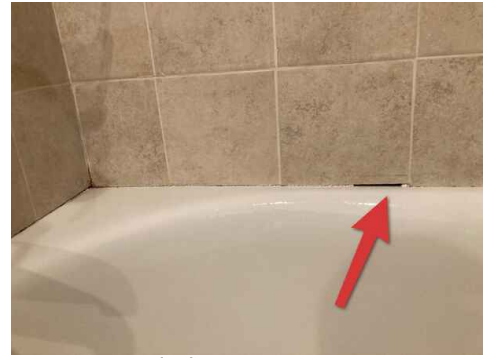
10.2.1 Shower

SHOWER CAULKING

Re-grout gaps around tile in the shower. Gaps in the tile can lead to water penetration and water damage.

Gaps around tile

Contact a qualified tile contractor

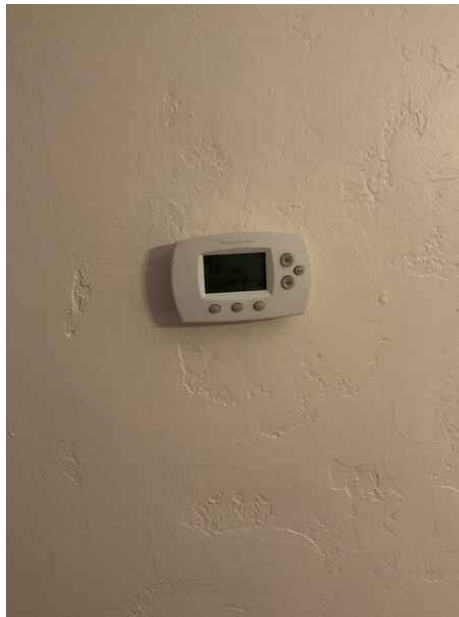
Thermostat Controls: Condition

Thermostat works from normal operating controls

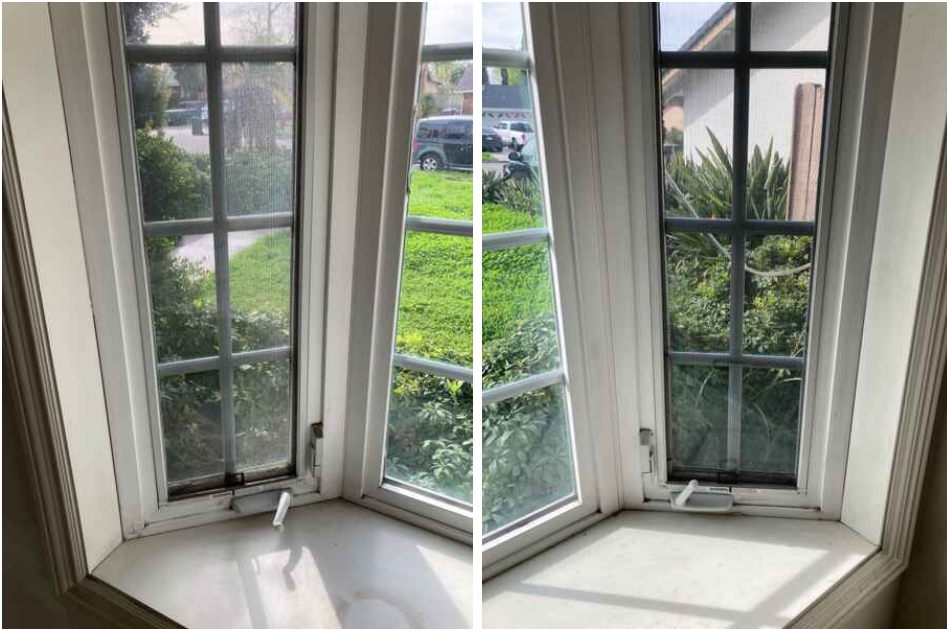
11.2.1 Windows

DAMAGED

One or more windows appears to have difficulty opening. Recommend a window professional clean, lubricate & adjust as necessary.

Contact a qualified window repair/installation contractor.

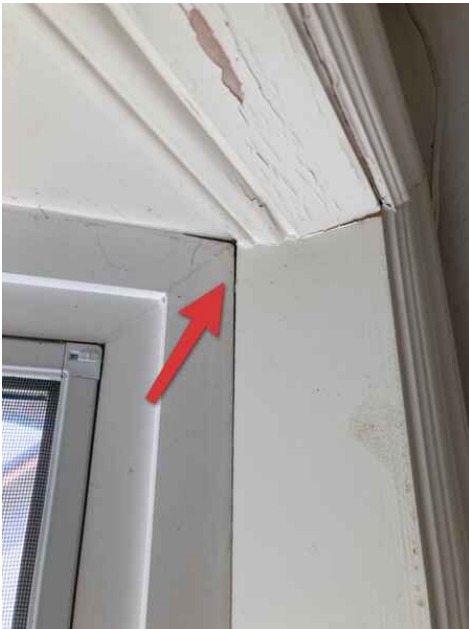
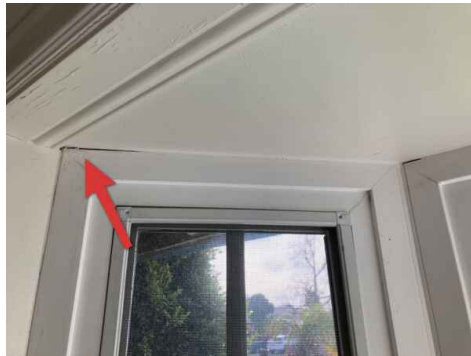
11.2.2 Windows

WINDOW SEALING

Gaps around window can lead to water penetration. I recommend re-caulking around window to seal, gaps and prevent moisture intrusion

Contact a qualified professional.

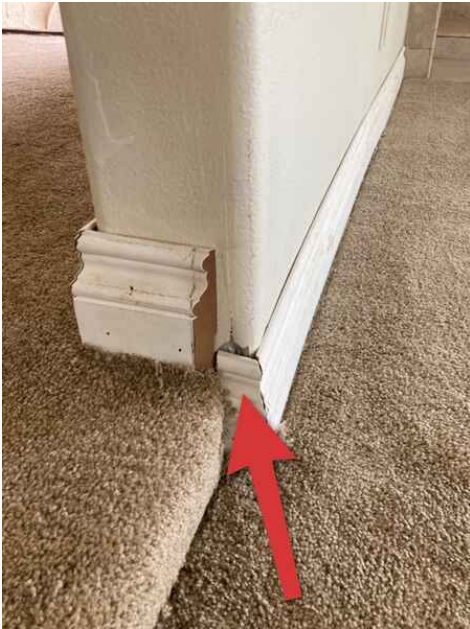
11.4.1 Walls

DAMAGED CORNER

Damage to corner of the drywall.

Contact a qualified professional.

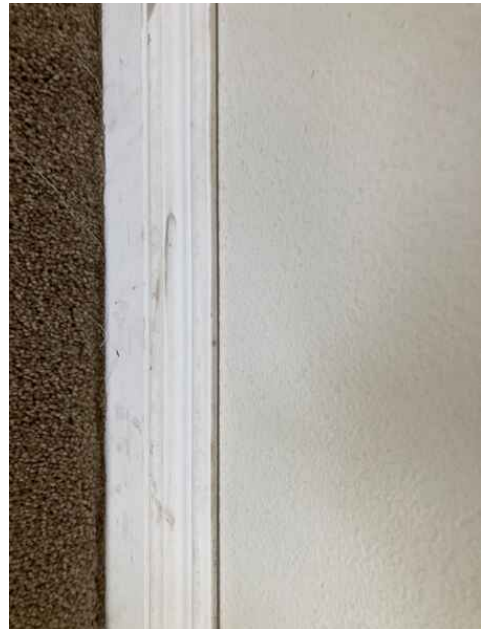
11.9.1 Crown moulding

I recommend crown molding be recaulked

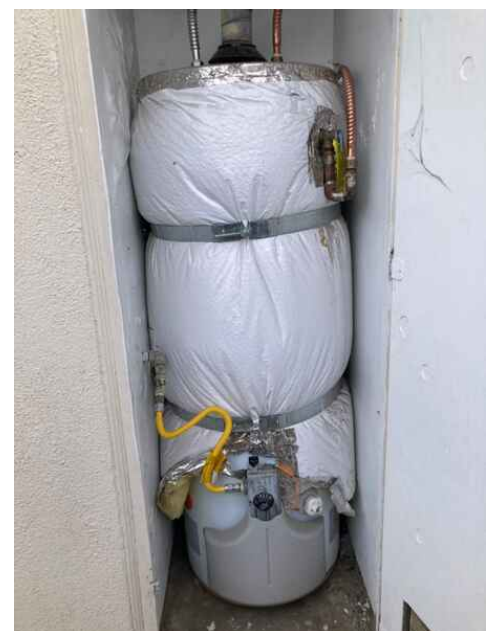
ACCESS BLOCKED

Access to water heater information was blocked by occupant insulation.

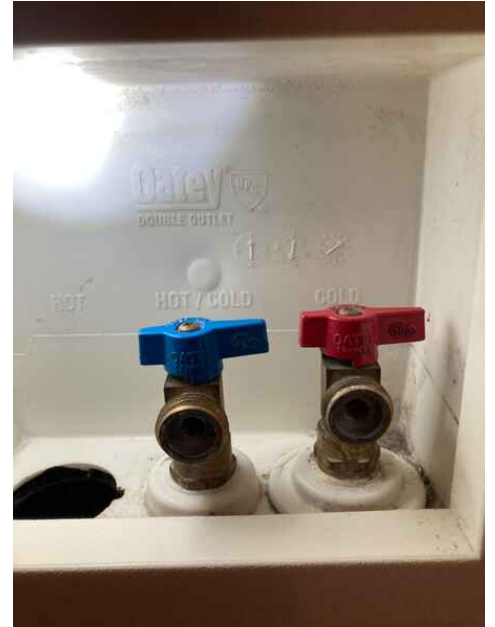
**IMPROPER CONNECTION**

An improper connection was observed at a drain, waste or vent pipe. Hot and cold water supply mislabeled. I recommend a qualified plumber evaluate and repair.

Contact a qualified plumbing contractor.

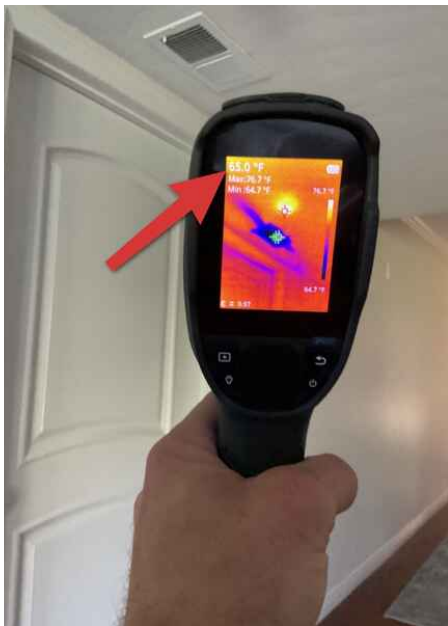
Cooling Equipment: Temperature Reading

Air condition was blowing cold out of all registers throughout the house. Thermal imaging camera was used to get reading.

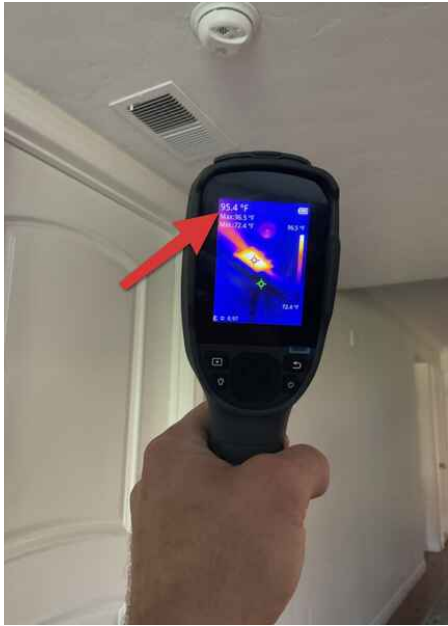
Heating Equipment: Temperature Reading

Heating unit was bowing out all all registers throughout the house. Thermal imaging camera was used to record temperature.

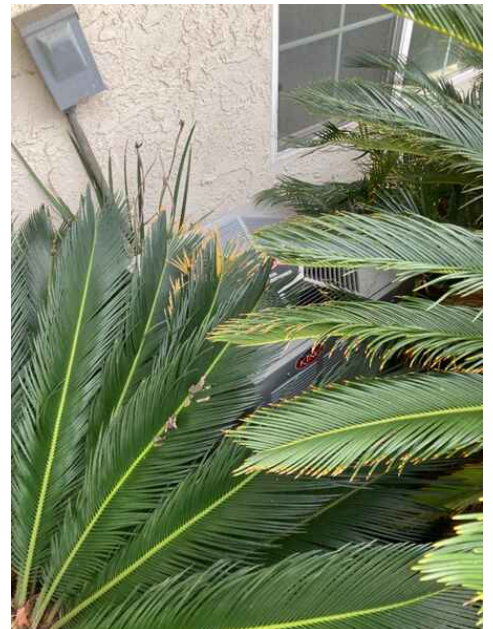
AC UNIT

AC unit surrounded by overgrown bushes, making inaccessible to get to

Vegetation was too close to the compressor, which can limit heat dissipation and limit effectiveness. Recommend cutting back vegetation to avoid overheating compressor.

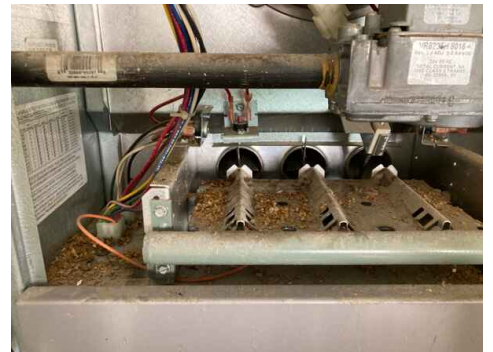
13.2.2 Heating Equipment

CONDITION

Heating unit is dirty, but is still within the lifespan of its usage. Recommend cleaning.

Recommended DIY Project

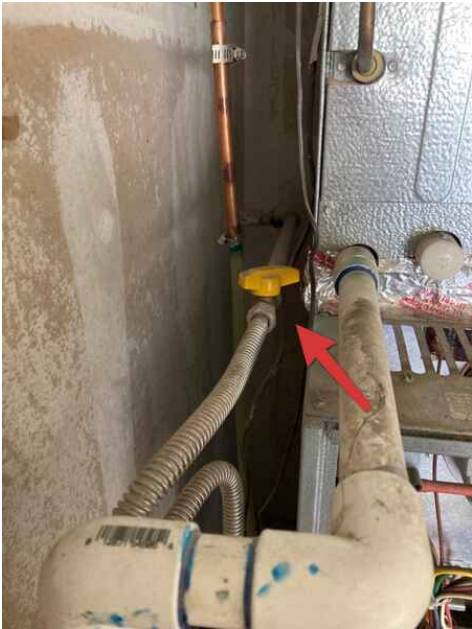
13.2.3 Heating Equipment

Industry standards recommend that gas line going into heater have a hard line with a sediment trap installed. The sediment trap helps prevent debris from entering the unit .helping it prolong the lifespan.

No sediment trap

Contact a qualified plumbing contractor.

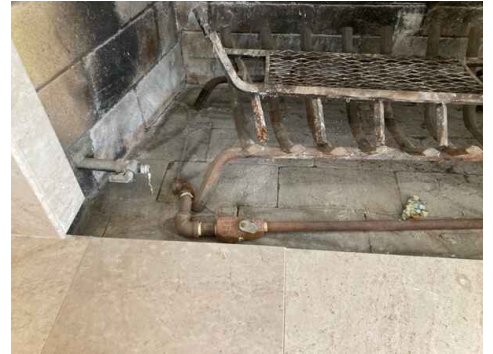
Gas line not connected to the burner. Valve is also already open. I recommend checking with a licensed professional to see if the gas line is operable.

Contact a qualified professional.

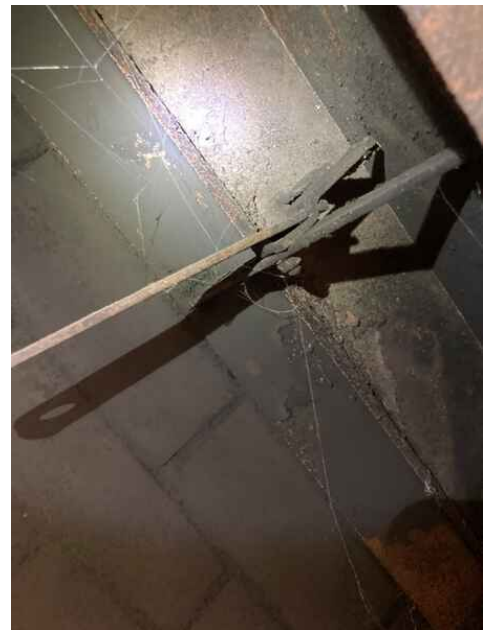
14.2.2 Vents, Flues & Chimneys

CHIMNEY LINER DIRTY

Chimney liner had layer of creosote dust, so underlying structure couldn't be inspected for cracks. Recommend qualified chimney sweep company inspect and/or clean.

Contact a qualified chimney contractor.

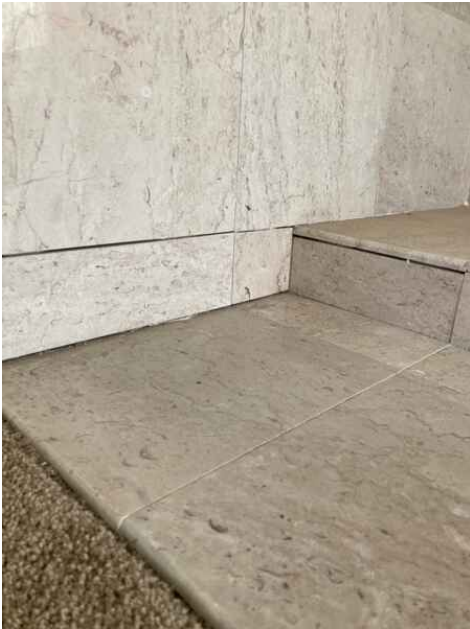
14.2.3 Vents, Flues & Chimneys

CHIMNEY MANTLE

Tile around chimney is missing grout in multiple areas.

Contact a qualified professional.

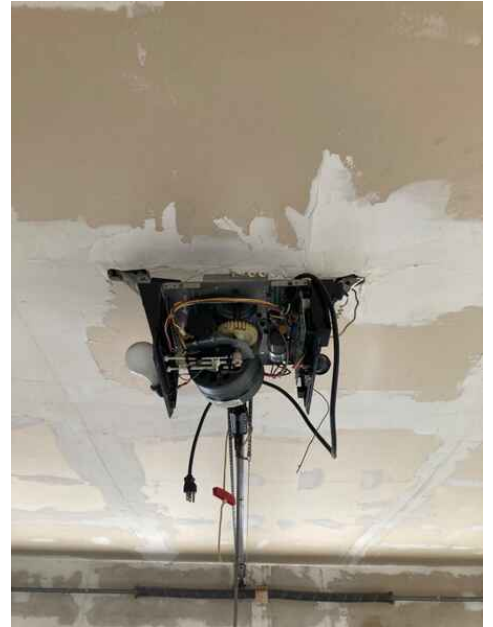
Garage door mechanism, missing cover, and is non-operable.

Garage door motor

Contact a qualified professional.

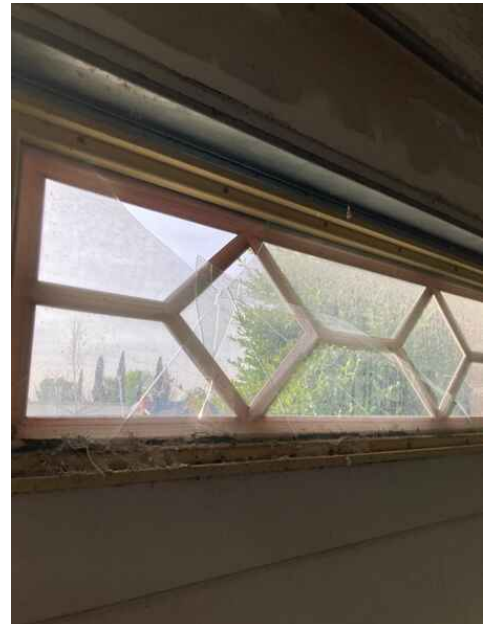
15.1.2 Garage door opener

Garage door window is broken. I recommend contacting a qualified professional to repair window.

Broken window

Contact a qualified garage door contractor.

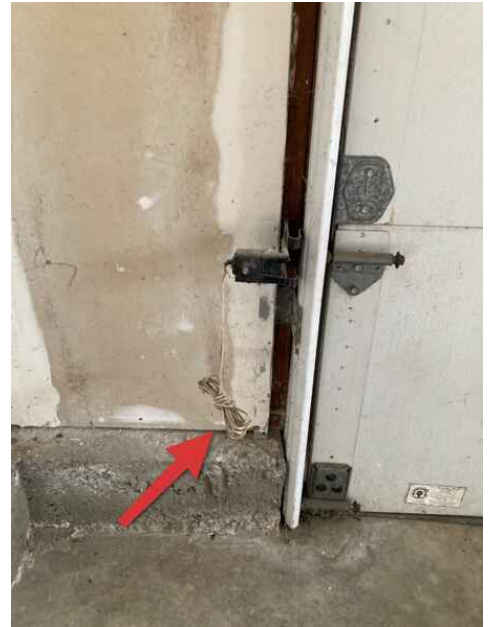
15.1.3 Garage door opener

Sensor not connected

Contact a qualified professional.

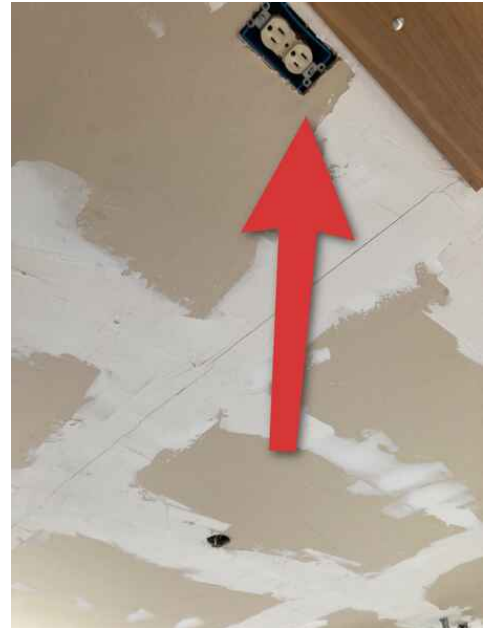
15.1.4 Garage door opener

One or more electrical receptacles not covered. I recommend installing cover plates to prevent electric shock.

Contact a qualified professional.

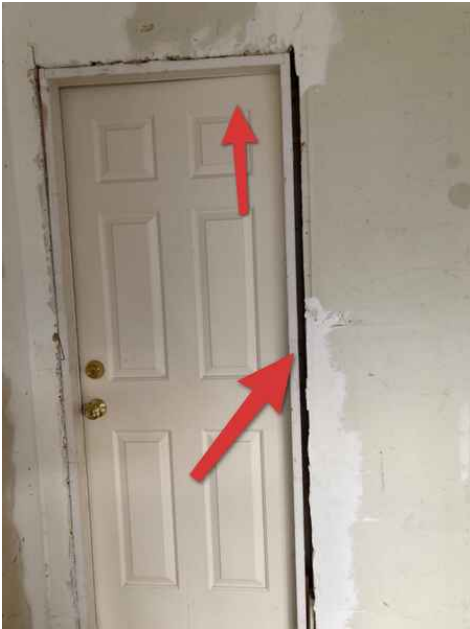
15.1.5 Garage door opener

Door that leads into garage has large gap around the door frame. Recommend sealing opening.

Open gap, no automatic closing mechanism

Contact a qualified professional.

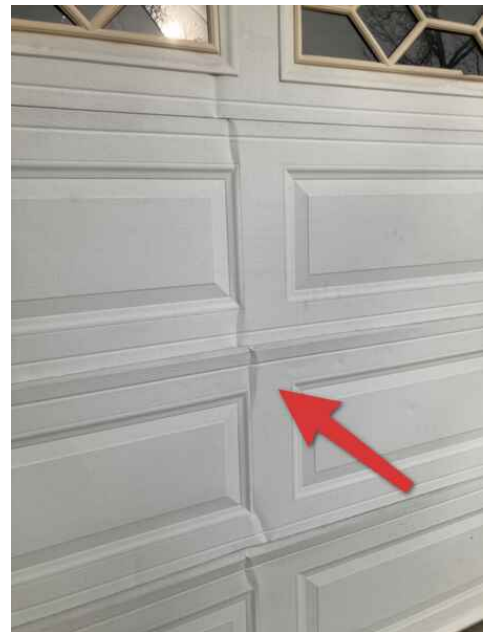
15.1.6 Garage door opener

Garage door shows signs of damage. Consult garage door technician for further evaluation.

Damaged garage door

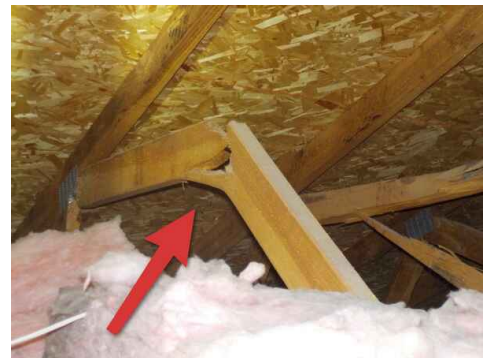
BROKEN TRUSS

Wood truss is broken in one location. The truss helps distribute the weight of the roof over a large span. I recommend a licensed roofing contractor evaluate and repair.

Broken truss
